DOCUMENTING A CENTURY-OLD FARMHOUSE IN FILIPY, WYSZKI COMMUNE, NORTH-EASTERN POLAND

Marta Arciszewska*, Patrycja Bartnicka*, Paulina Bielawska*, Jarosław Szewczyk**

In November 2018, and October 2021, a series of field surveys were conducted in *gmina Wyszki* (Wyszki commune) in northeastern Poland, some 60 km southwest of the region's capital city of Białystok, to identify any remnants of vernacular architecture that may have historical or cultural value. In particular, a century-old log house in Filipy was selected for more detailed research. Photographs and inventory drawings were taken to document not only the architectural form and construction of the house, but also its furnishing, equipment and interior adornments. It was the accumulative nature of the house's interior that proved crucial to its cultural value.

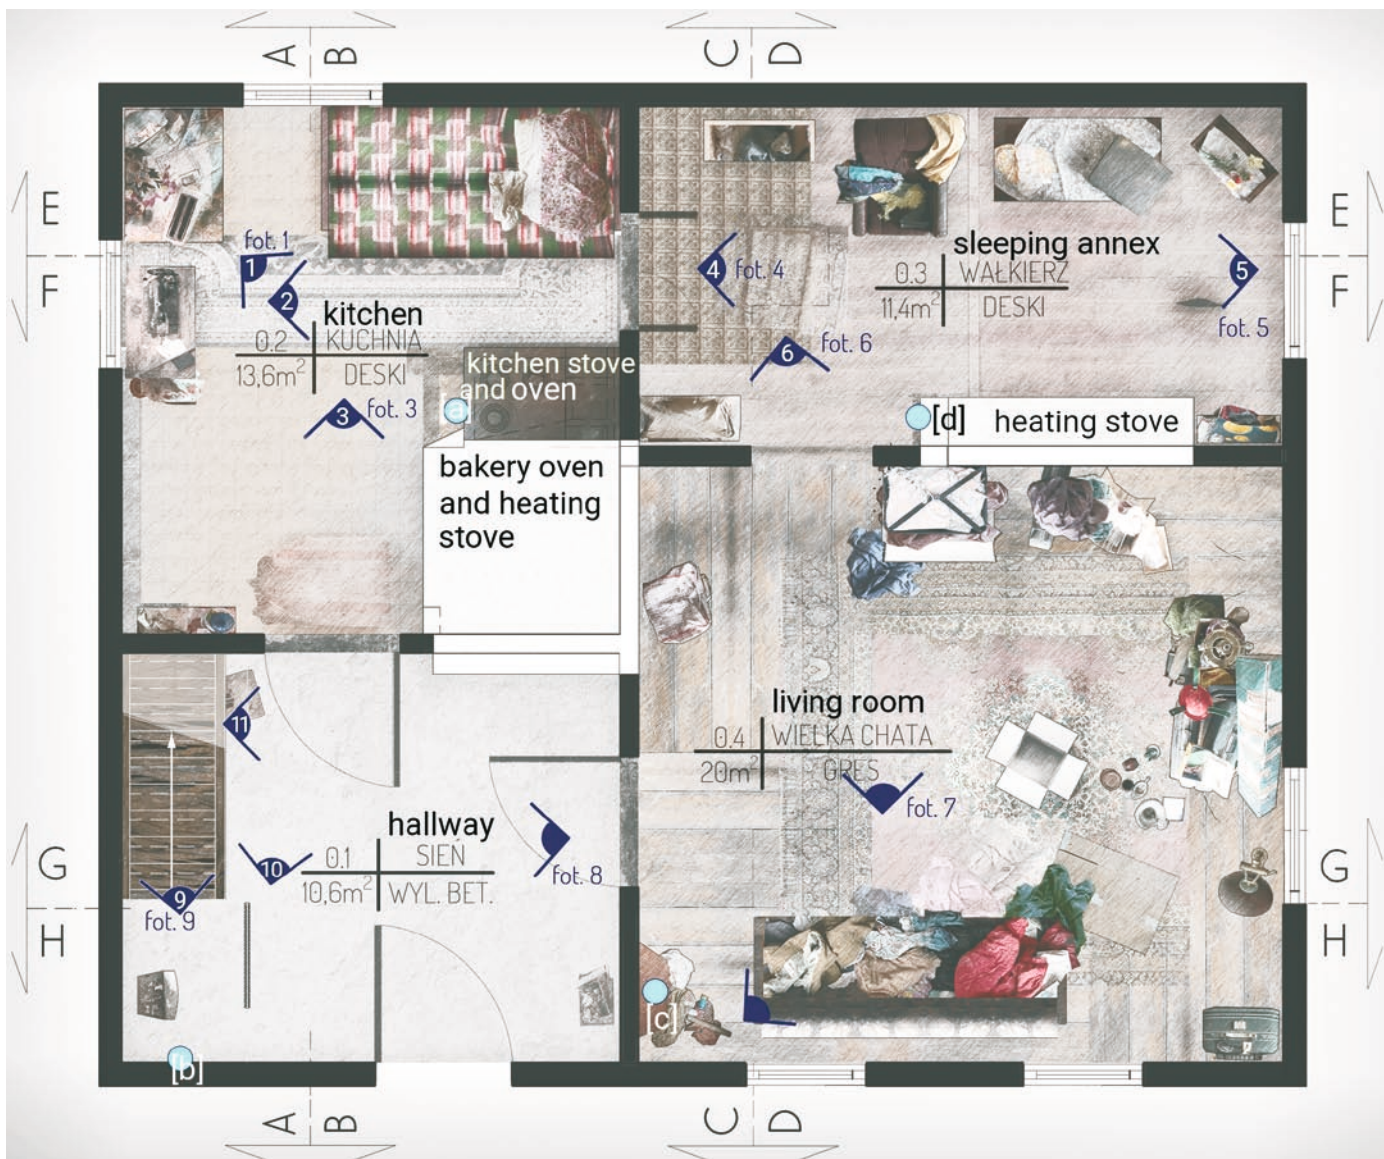
Fig. 4. The ground floor plan of the farmhouse; drawn by the authors, 2021

The layout of the house was specific for this region, i.e. common for petty gentry old farmhouses in northeastern Poland. There was an asymmetrical arrangement of rooms which were all adjoined to the large tile stoves and an oven. An enfilade (room alignment) allowed one to pass through all the rooms, walking around the central stove-and-oven system (Fig. 4). From a hallway (*sierń*) one could enter the kitchen which

- an elongated wall-like brick stove that separated the living room from the sleeping annex (Fig. 4[d], Fig. 7);
- in the kitchen: a large, wide cookstove with an oven (Fig. 4[a], Fig. 6.1);
- a short “hanging chimney” that rested on a ceiling beam (Fig. 5[f]);
- a system of smoke flues that connected the stoves with the chimney (Fig. 5).

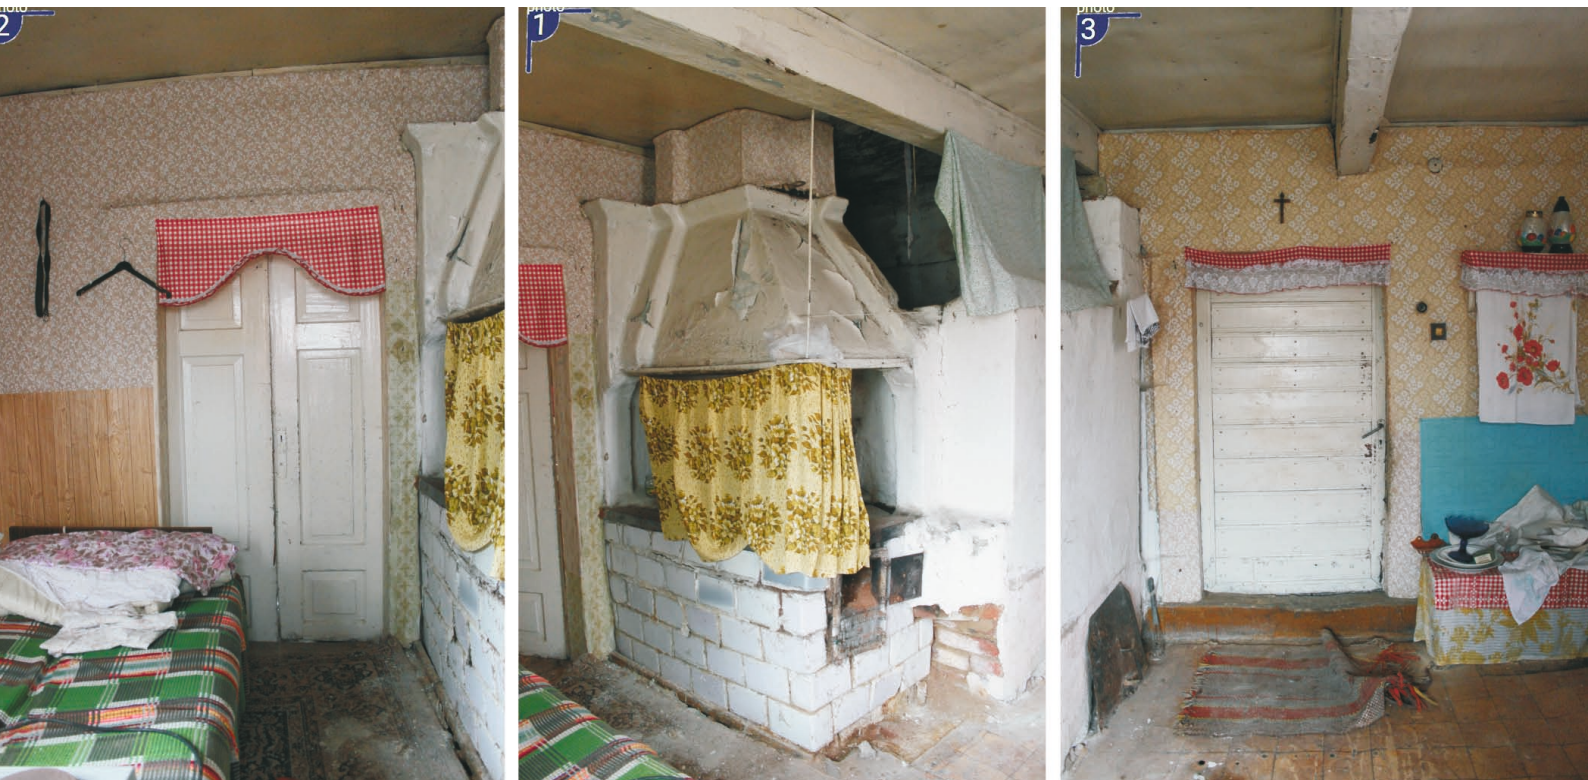
Fig. 6. The kitchen; photos by the authors, 2018

also served as a main space for everyday activities and was used for both sleeping and dining, and for either labour or leisure. Therefore, in the kitchen one could find a Singer treadle sewing machine (Fig. 15), a bed, a dining table, etc.

The functional, aesthetic and symbolic arrangement of the kitchen was diagonal: the stove was located in the southeastern corner, while the opposite northwestern corner of the kitchen was of some sacred nature, containing devotional objects. Such a diagonal arrangement (stove corner vs. devotional corner) was common for old eastern European homes, including the old farmhouses in the eastern part of the Podlaskie Region.

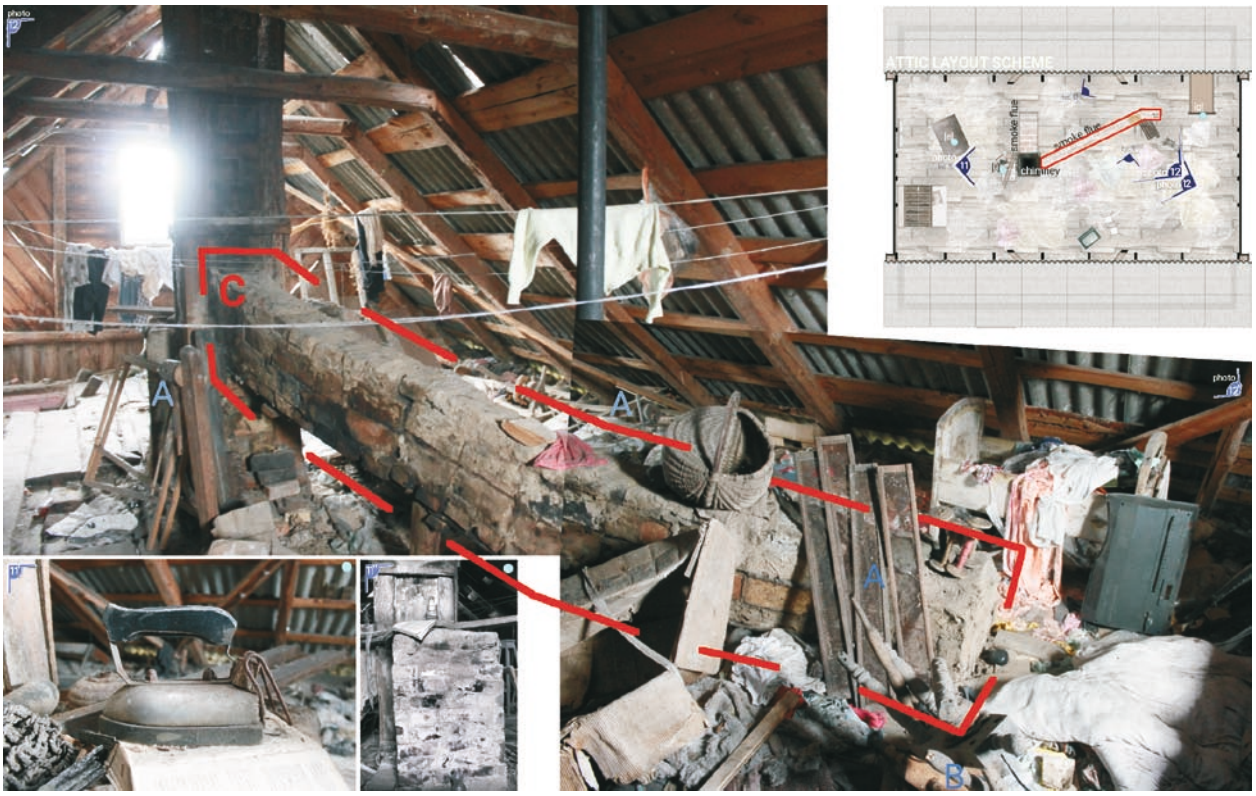
Fig. 11. The attic with the longest smoke flue (C) exposed; photos by the authors, 2018

The uninhabited attic was a storage space, sort of a “lumber room”, where one could find an old spinning wheel (Fig. 11: B), a loom dismantled into pieces (Fig. 11: A), an old smoothing iron (Fig. 11: photo 11), a few trunks or chests, outmoded furniture, baskets, old books etc.

The short “hanging chimney” (Fig. 12: A) was braced with four timber posts (Fig. 12: B) and the construction rested on three short logs (Fig. 12: C1, C2 and C3) that lay upon a ceiling beam, with no foundation or support beneath. The chimney was connected to stoves with three smoke flues: two short ones (Fig. 12: D) and one long one (Fig. 11: C).

The attic had not been converted into any habitable space, thus still serving as storage space or as a drying room, occasionally (Fig. 11, 12). Some attic space was occupied by a chimney system (Fig. 5, 11–15).

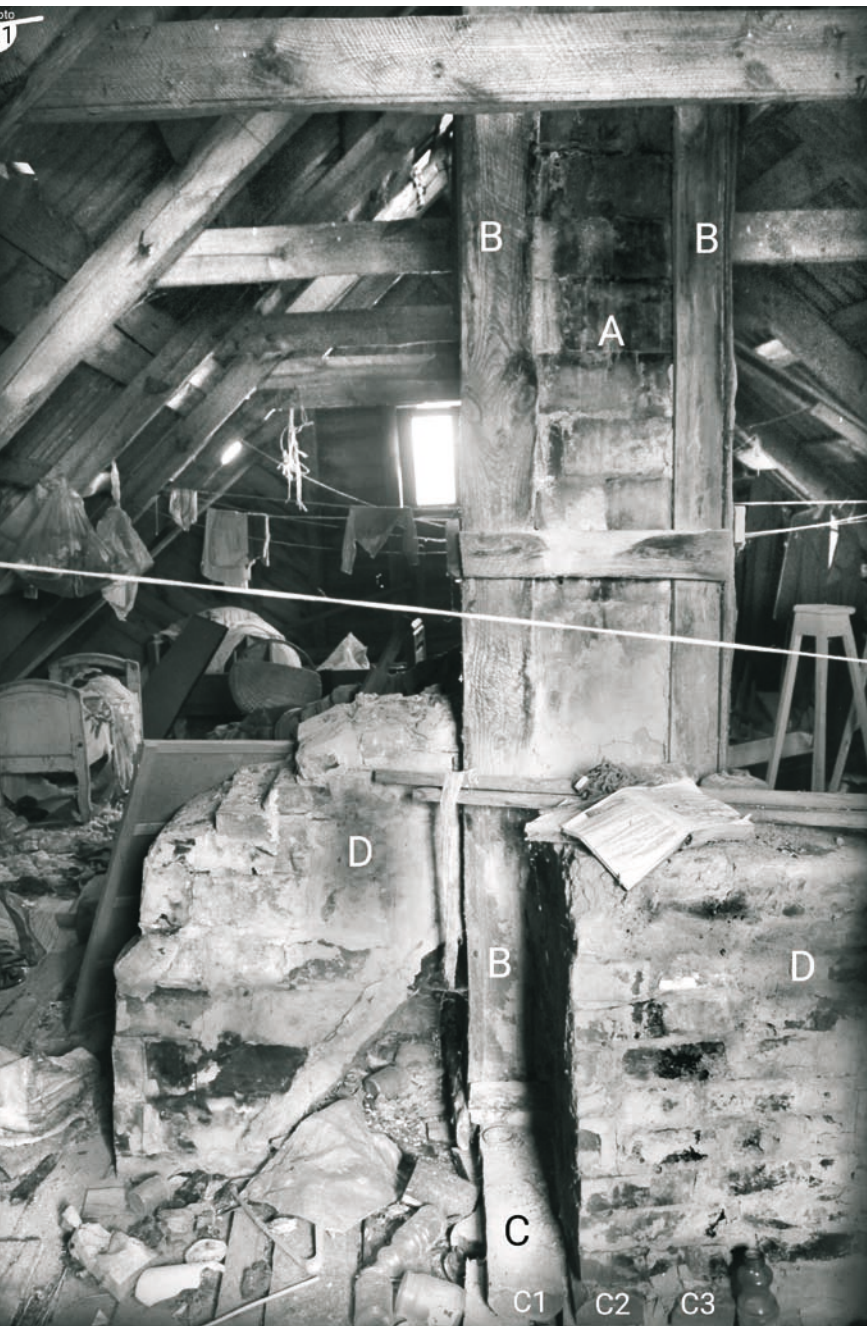
Fig. 12. The attic with two shorter smoke flues (D) exposed, and wooden braces (B) supporting the “hanging chimney” (A); photos by the authors, 2018

The “hanging chimney” and upper smoke flues in the attic floor are characteristic of north-eastern Poland, allowing for the operation of many stoves while only one short chimney was raised. Moreover, wooden bracket stakes (Fig. 12) stabilised, reinforced and buttressed the chimney, making it an aesthetic curiosity.

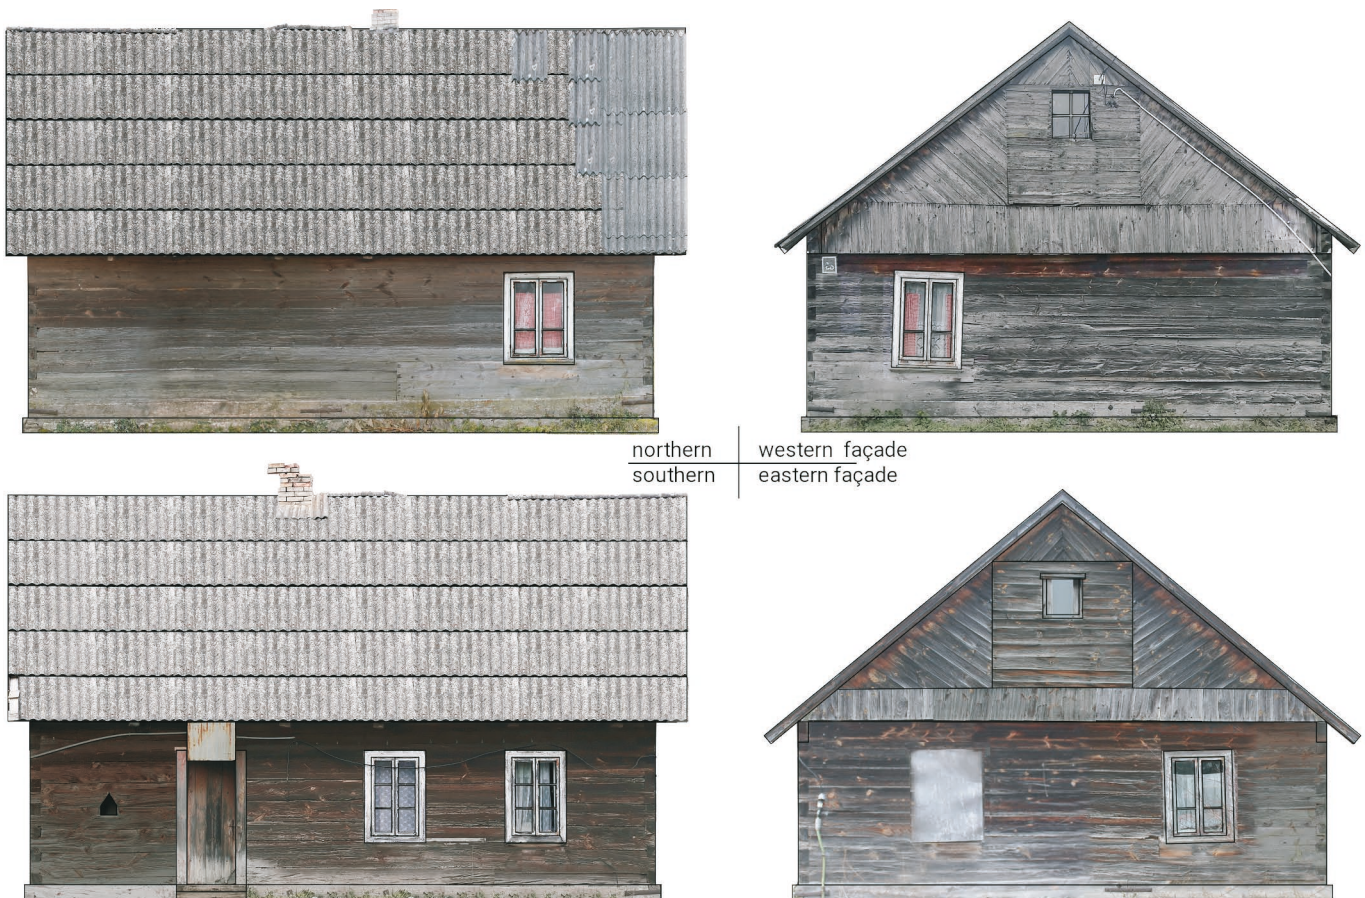
Fig. 24. Façades of the farmhouse; drawn by the authors, 2018

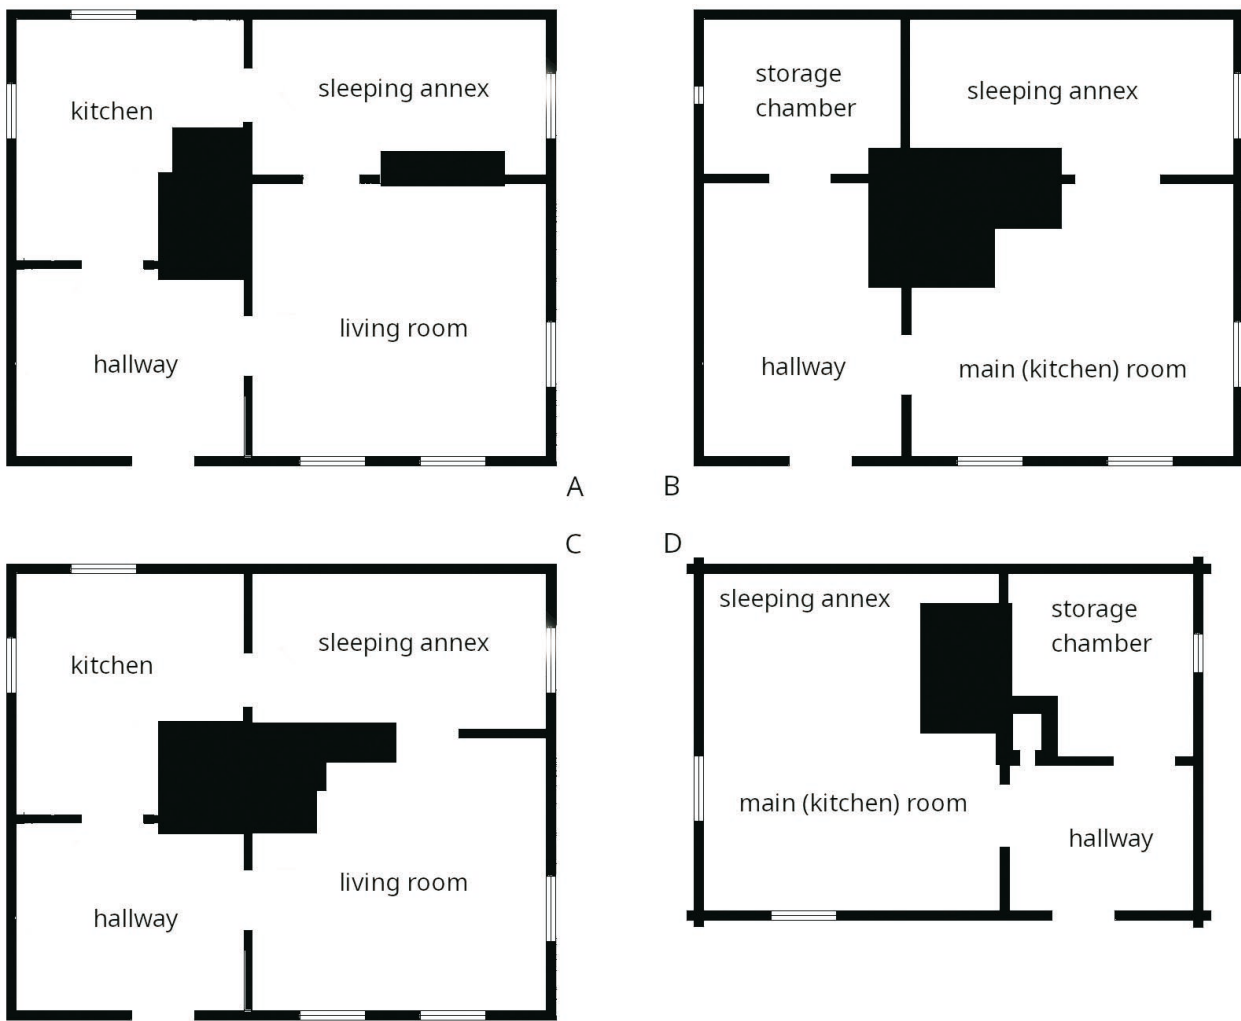
Fig. 26. The layout of the house in Filipy (A), as compared to other common layouts of old log houses in the region: B – an old house in Kiersnowo, according to Maria Parnowska [1961, p. 164], C and D – two simplest elementary types of a log cabin, in Piętki-Gręzki [M. Pokropek, T. Strączek 1993, pp. 106 and 113]

As it has been stated above, an enfilade (room alignment) around the central stove-and-oven system was typical not only for many “asymmetric broad-front system” houses in the region [see M. Pokropek, T. Strączek, 1993], including the smallest and the most ancient types of log cabins (Fig. 26), but was also the basic scheme for more complex and larger layouts of many farmhouses erected in the mid-20th century until the late 1960s. So did the enfilade layout of the house under study grow out of old regional folk building traditions or, conversely, was it already a manifestation of a widely disseminated twentieth-century building culture?

The simplest (elementary) type of 19th-century log cabin, classified as of “asymmetrical broad-front layout”, provided a kind of “backbone” for later farmhouses that continued its line of development until the complete cultural paradigm shift in the late 1960s. This is also the case of the farmhouse in Filipy. However, in this case and in other houses of that type (in older farmhouses or even in somewhat newer ones) it is sometimes difficult to precisely define the ranges of influence, namely whether and to what extent the present (existing) layout, forms, furnishing and decoration of the
