THE BARN COMPLEX IN MSTÓW: CULTURAL VALUE, REVITALIZATION, AND CHALLENGES IN PRESERVING REGIONAL ARCHITECTURE

Andrzej Kos*, Nina Sołkiewicz-Kos**

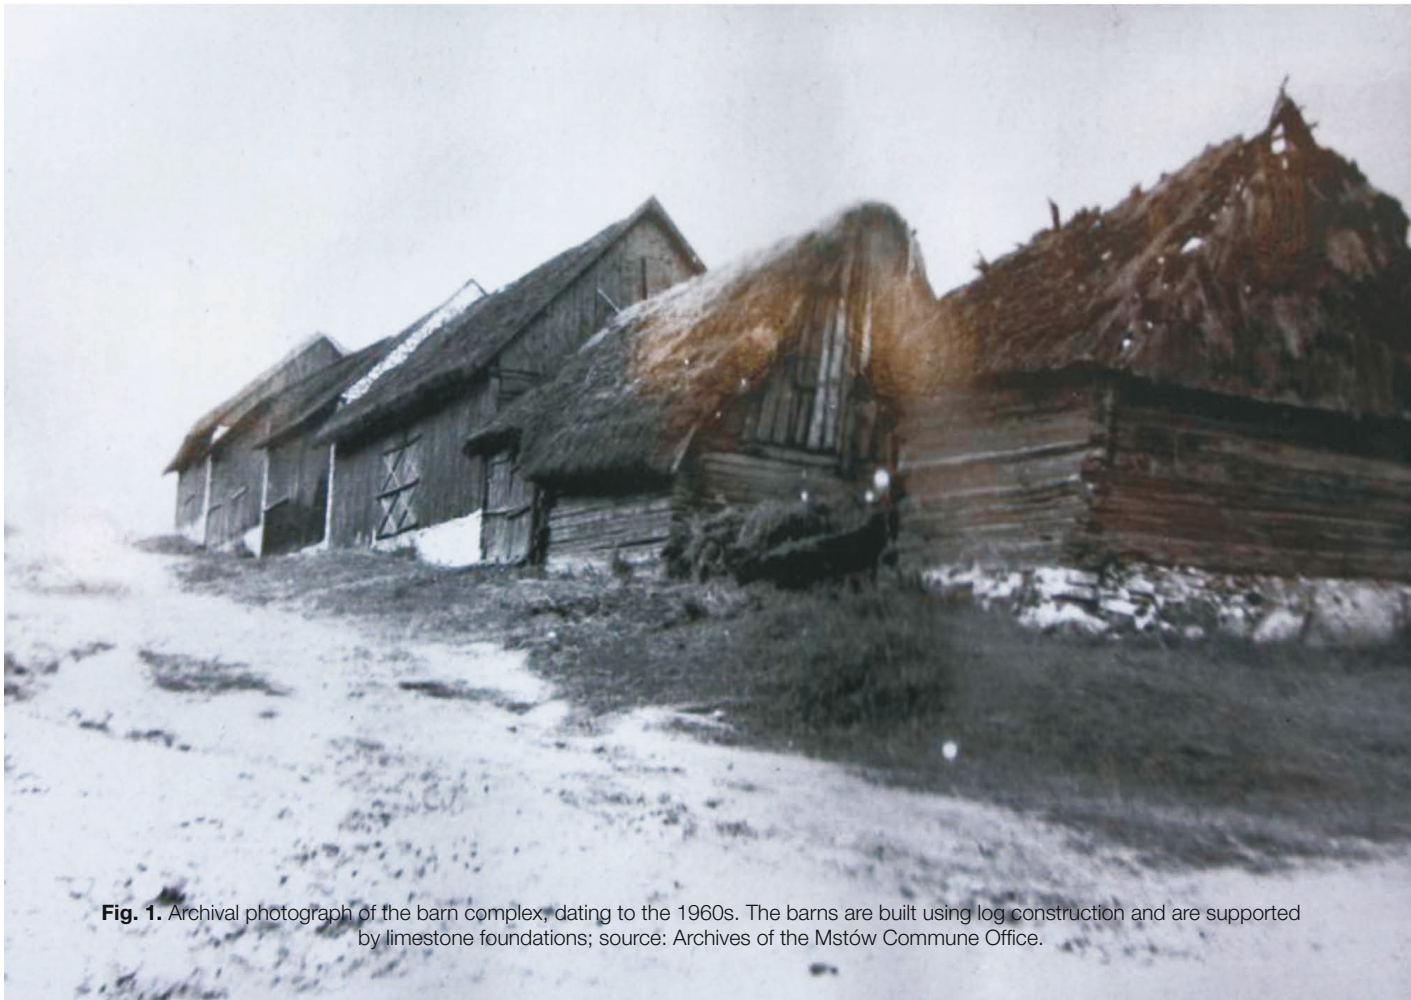
Fig. 1. Archival photograph of the barn complex, dating to the 1960s. The barns are built using log construction and are supported by limestone foundations; source: Archives of the Mstów Commune Office.

The first barns were built using traditional timber log construction methods typical of the region; Fig.1. Over time, construction techniques evolved: timber-frame structures were introduced, followed by more durable barns made of limestone from nearby quarries. This progression resulted in three types of barns: timber barns with stone foundations, mixed stone-and-timber barns (with stone gable walls), and fully stone-built barns. These changes reflected the need for greater durability and the availability of materials [M. Trawińska 1966, p. 99].

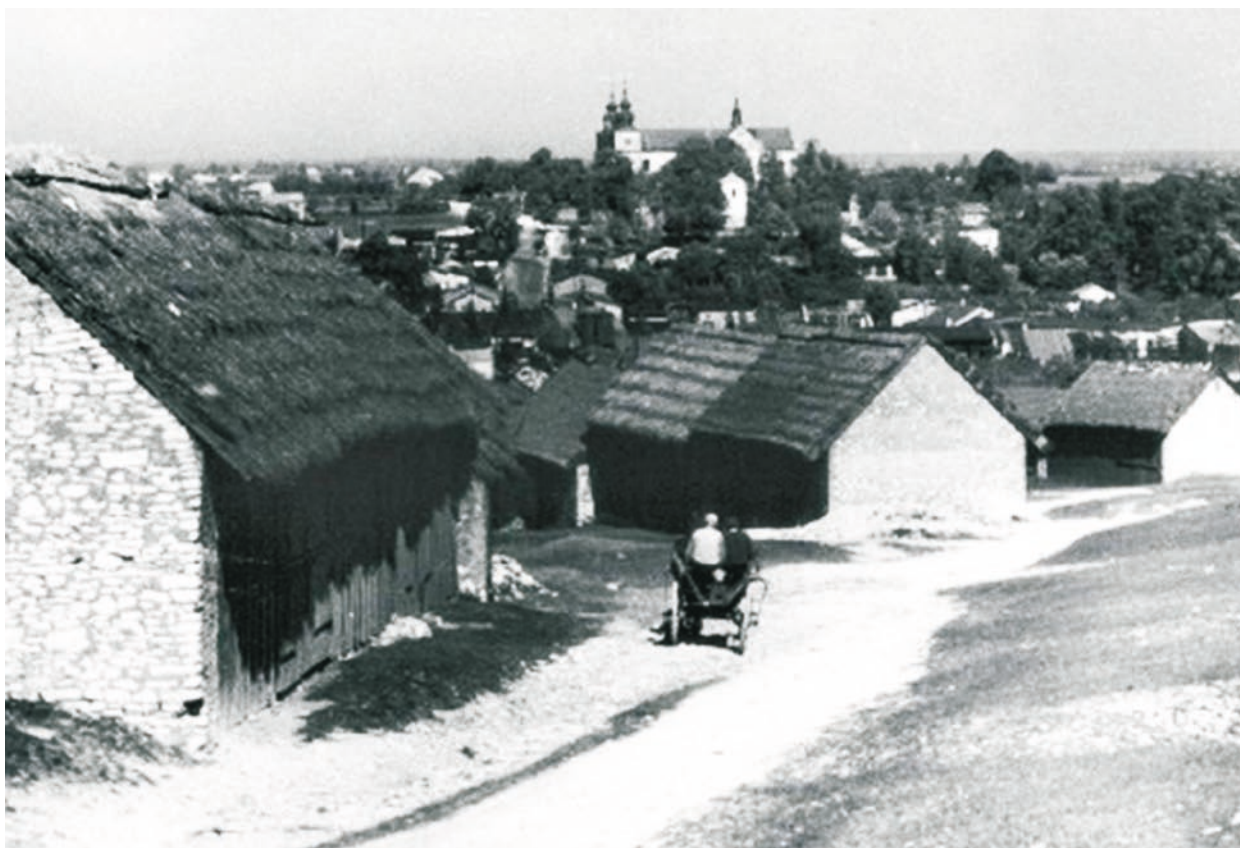
Fig. 2. Archival photograph of the barn complex, dating to the 1960s. The closely spaced buildings formed continuous frontages along a road resembling a street. In the background, Szwajcer Hill with the monastic complex of the Canons Regular; source: Archives of the Mstów Commune Office.

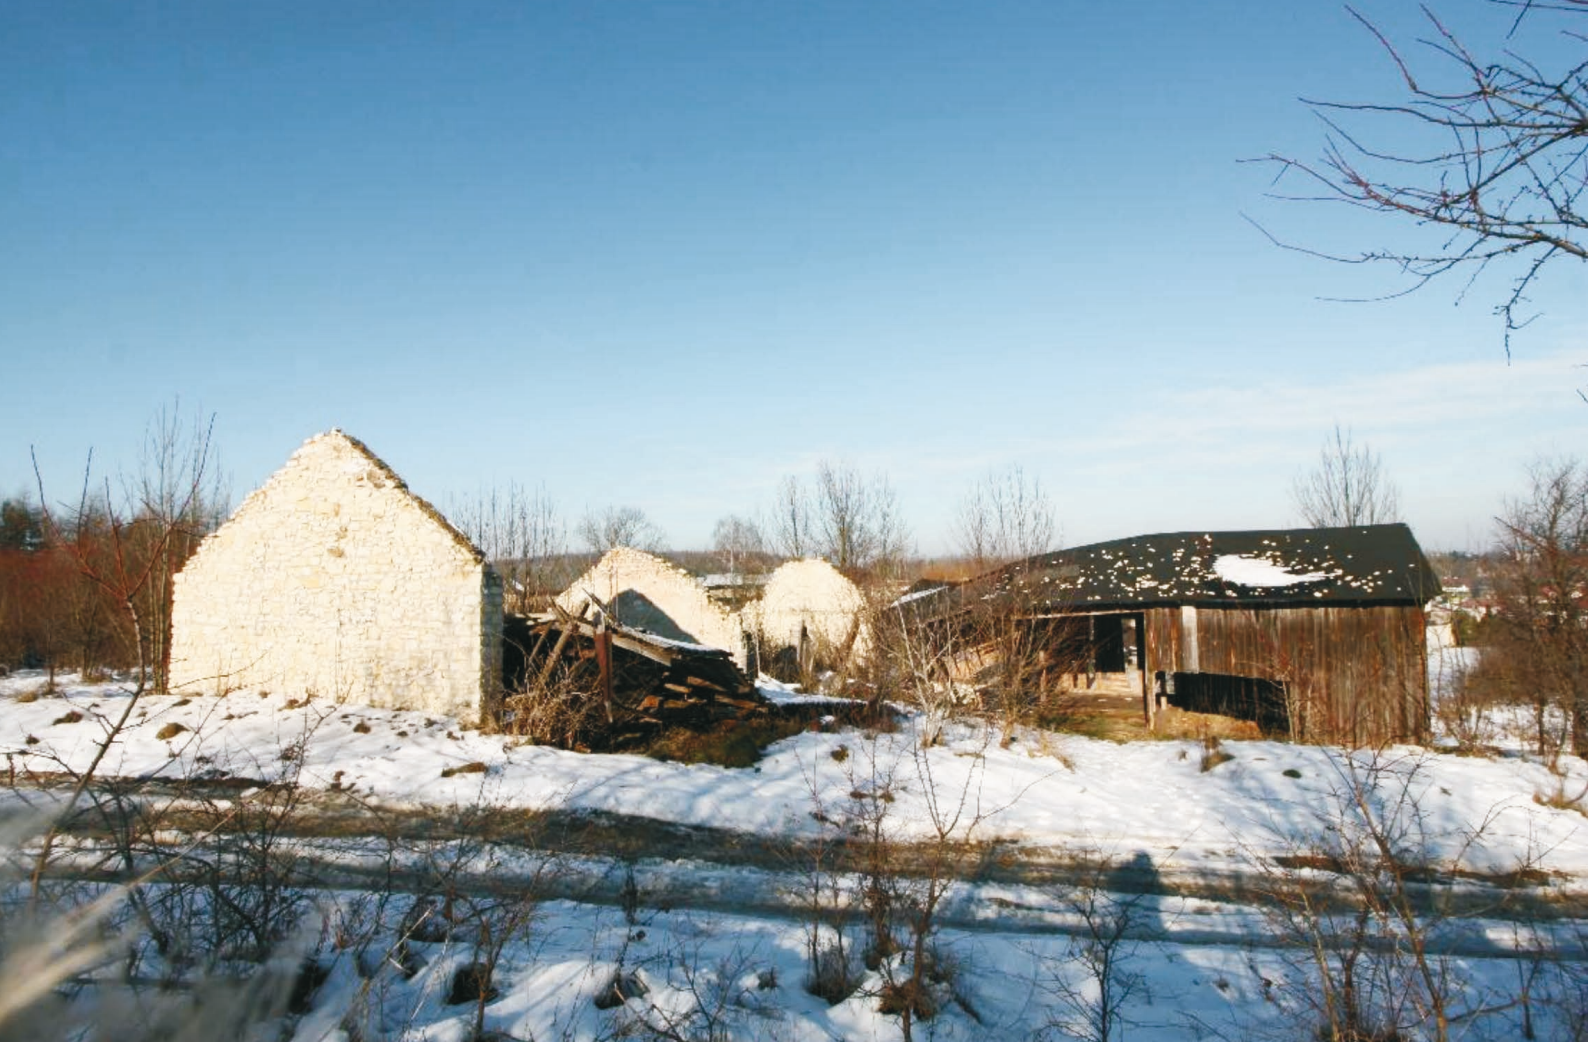
Fig. 7. Current condition of the barn complex in Mstów. The photograph shows the stone gable walls of Barn No. 1 and Barn No. 2 (with a shared central wall). On the right side, Barn No. 3 with its timber structure visible. The buildings are in a state of ruin; source: photo: Andrzej Kos, February 2025.

The inclusion of the complex in the Municipal Register of Historic Monuments in 2012 aimed to place it under conservation protection; however, the lack of further actions and regular maintenance work has contributed to the acceleration of degradation processes. The greatest threats to the structural stability of the buildings are the damage to (or absence of) roofs and the deterioration of foundations, which, under the influence of weather conditions such as precipitation, frost, and temperature fluctuations, have been steadily worsening. The erosion of limestone and the degradation of timber elements, exacerbated by the lack of protection against external factors, have led to irreversible losses in the historic fabric. Conservation challenges also stem from limited financial resources and insufficient engagement from local authorities and the community. The lack of awareness of the historical value of the complex further complicates the possibility of undertaking effective preservation efforts; Fig. 7, Fig. 8, Fig. 9, Fig. 10.

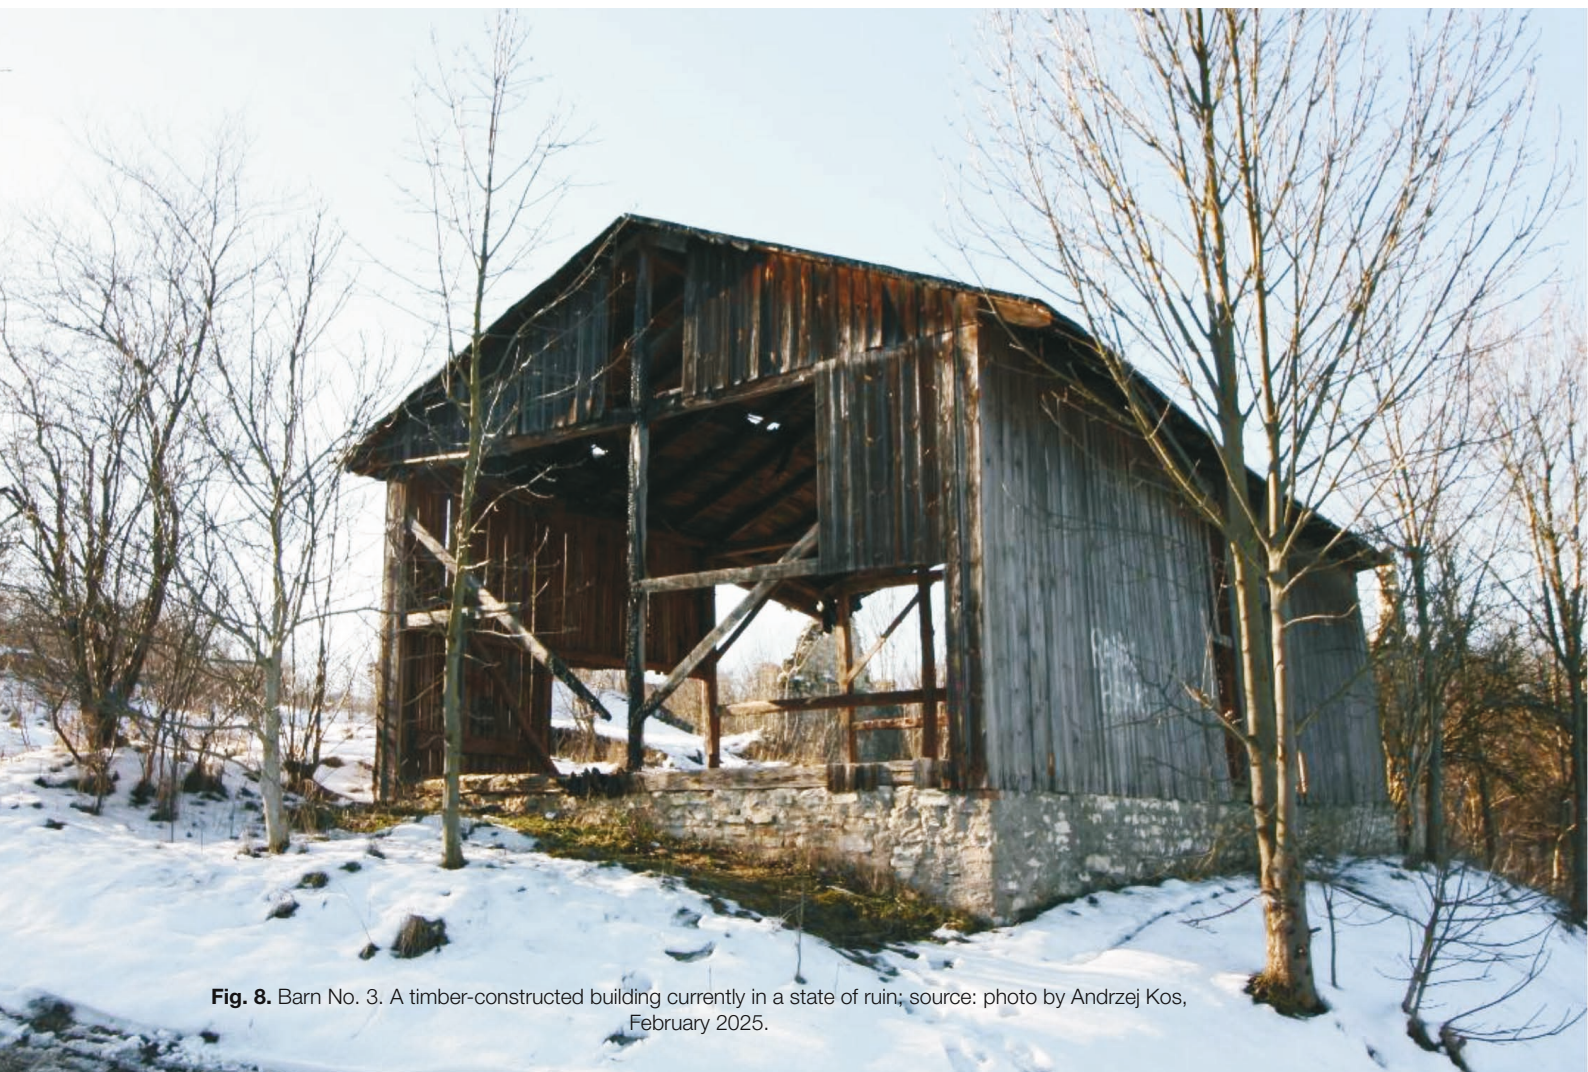
Fig. 8. Barn No. 3. A timber-constructed building currently in a state of ruin; source: photo by Andrzej Kos, February 2025.

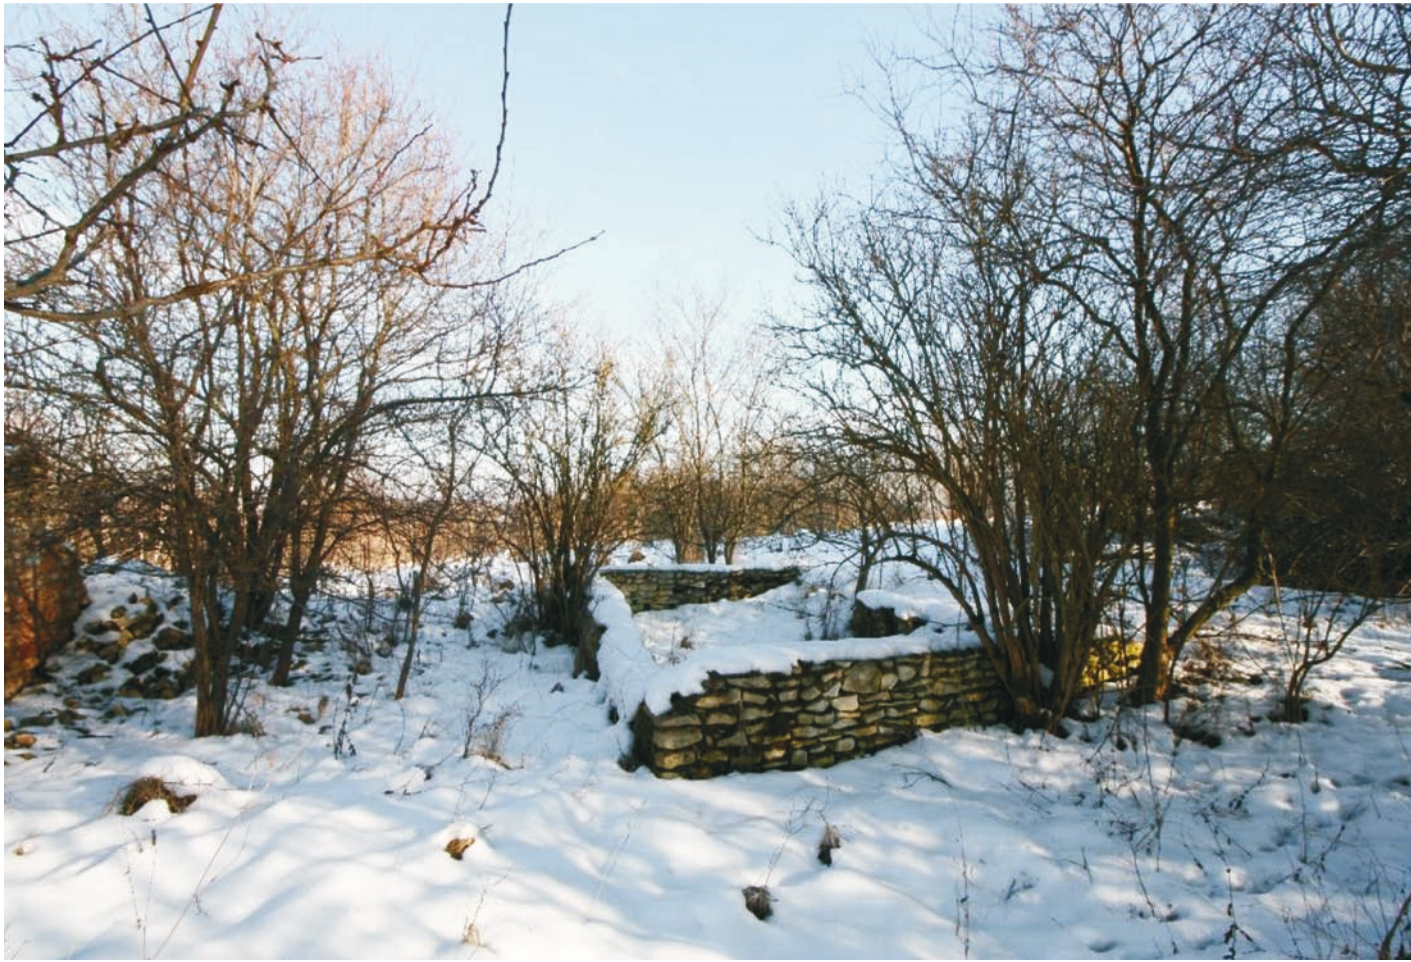
Fig. 9. Barn No. 4. The timber-constructed building has been completely destroyed. Remnants of the structure 2 a fragment of the stone foundation made of field limestone – have survived; source: photo by Andrzej Kos, February 2025.

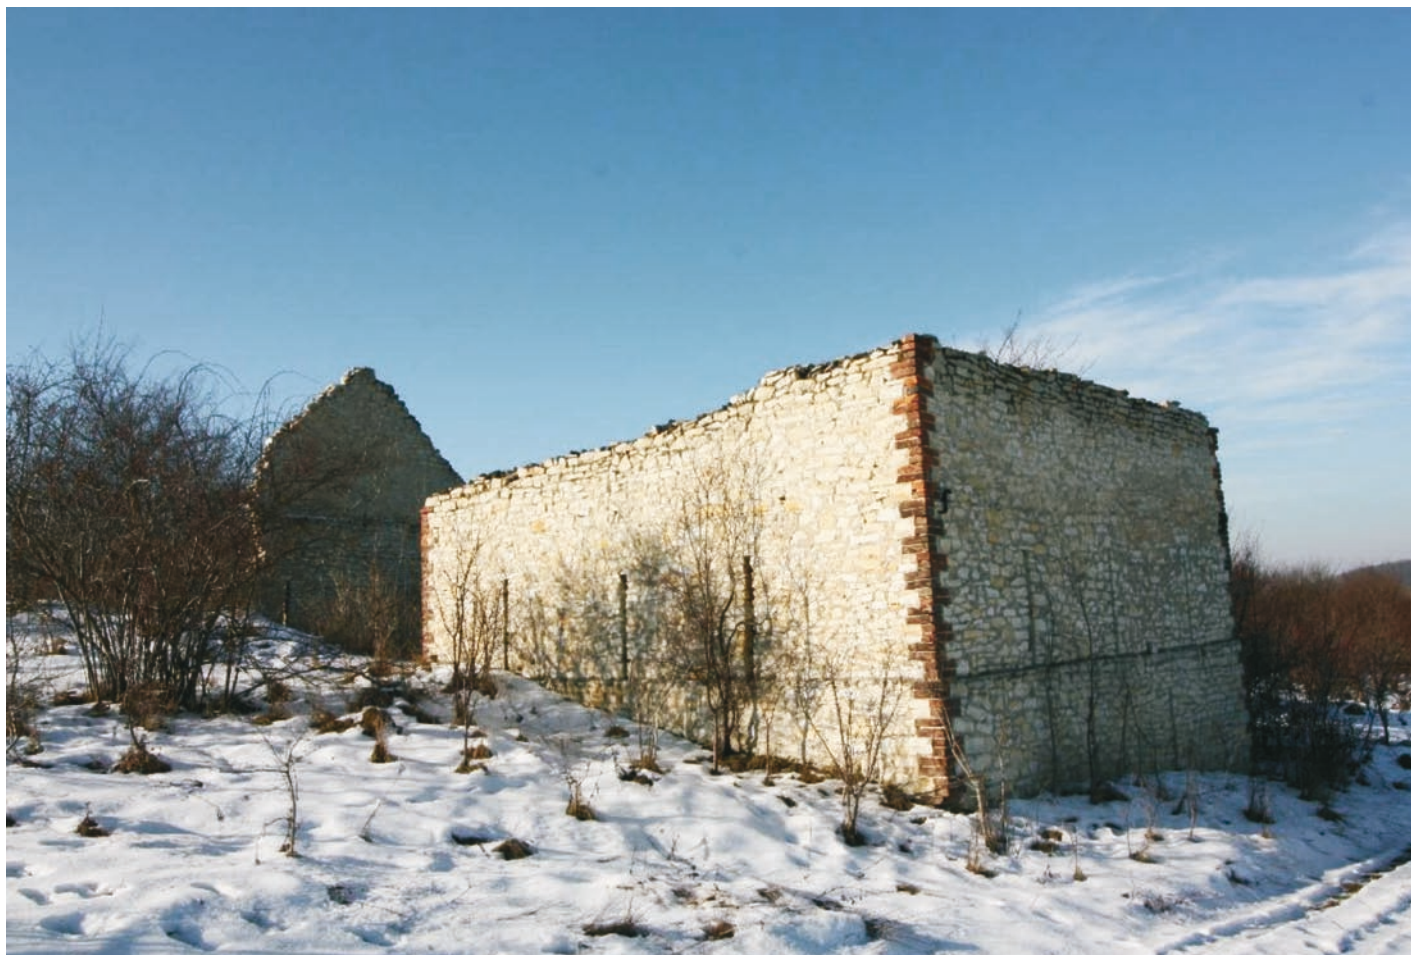
Fig. 10. Barn No. 5 in Mstów. The building is in a state of ruin. A portion of the perimeter walls has been preserved; source: photo by Andrzej Kos, February 2025.

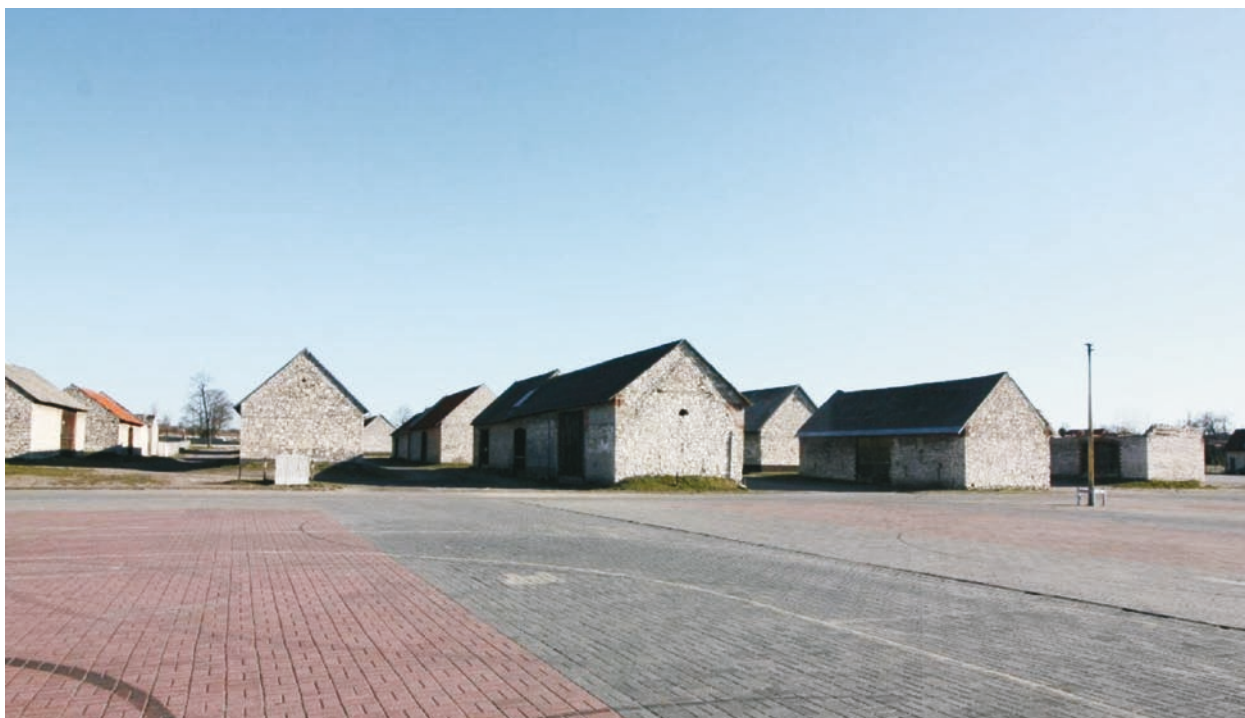
Fig. 11. An example of a revitalized barn complex in Żarki. The restored structures have gained new functional purposes, highlighting the contrast between the preserved complex in Żarki and the neglected condition of the barns in Mstów;
source: photo by Nina Solkiewicz-Kos.

The Żarki barns, located conveniently near the town, were rebuilt after a fire in 1938 using local limestone and brick, with ceramic tile roofs ensuring durability. Successful revitalization efforts by the municipality adapted the barns for modern uses, such as regional trade, cultural events, and tourism. This initiative has enhanced their value to both the local community and visitors, serving as a model for adapting heritage sites to modern needs; Fig. 11.
